Arbor Options, LLC
Tree Consultants

Memorandum

Site: 2203 NW 63rd Street & 6211 22nd Avenue NW Seattle, WA 98107

Subject: Tree Inventory and Protection Memo

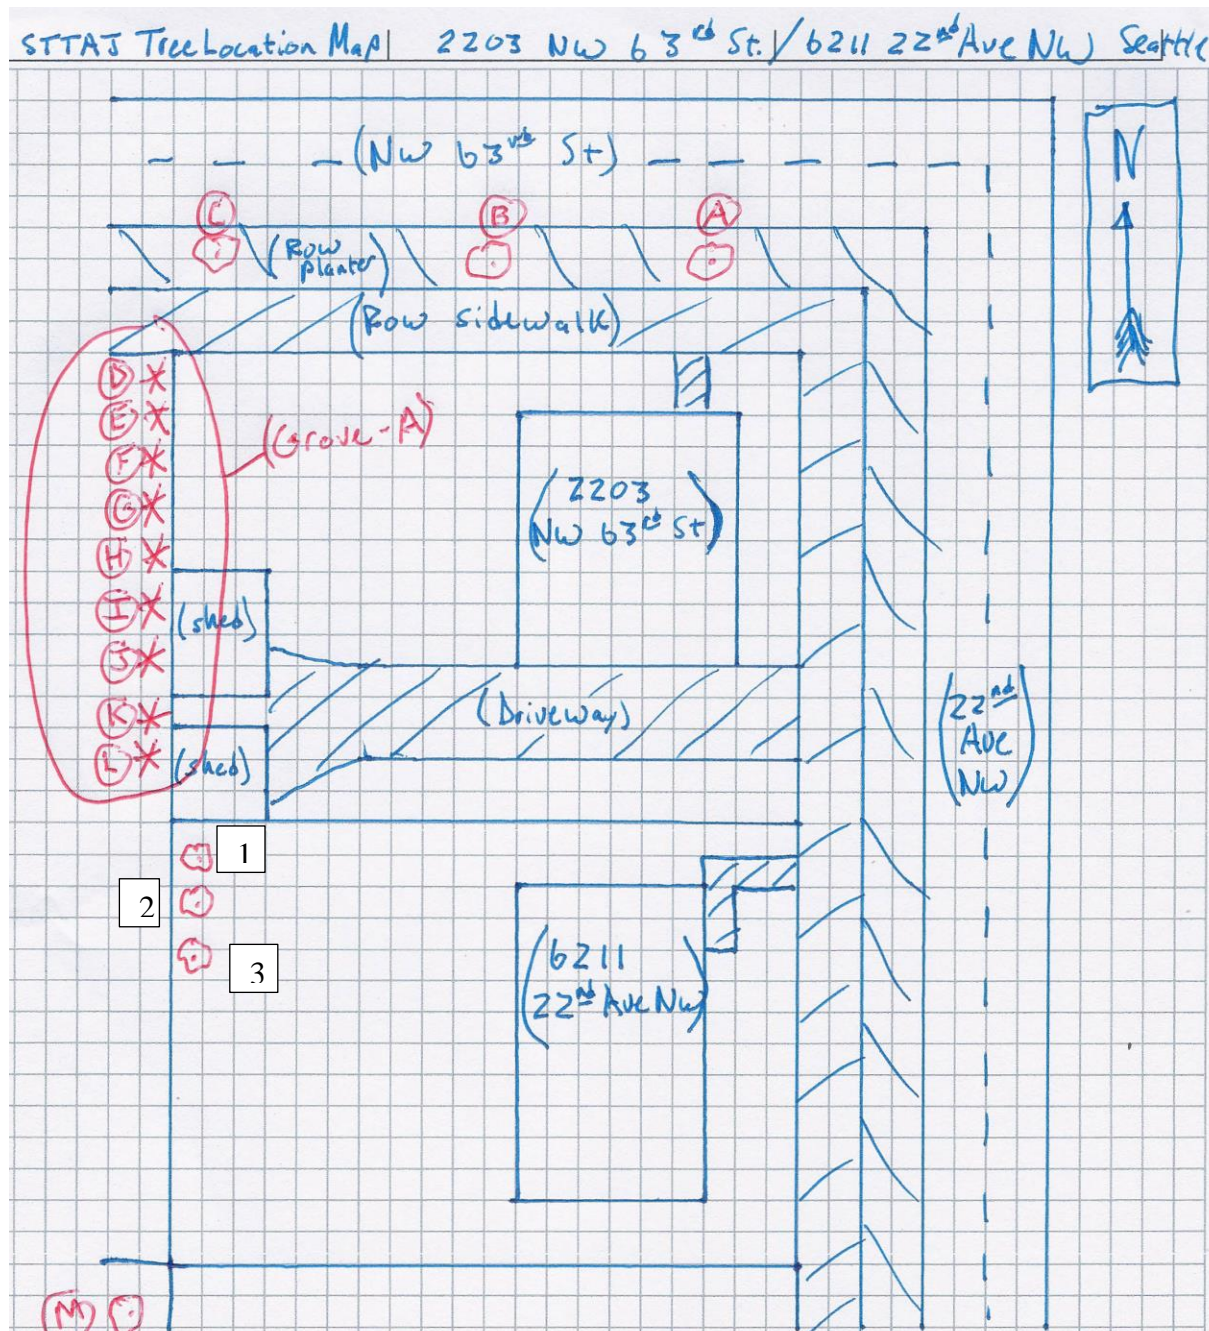
Appendix A- Tree Location Sketch

Note: Map is not to-scale, and tree locations are approximate.
